**Flood Control Project Maintenance  
Levee Inspections****LMA District Cover Sheet****Spring 2015 Levee Inspection Results****Reclamation District No. 0003 Grand Island**

**Spring 2015 Levee Inspection Results**

**Reclamation District No. 0003 Grand Island**

**Levee Inspection Report By Mile - Spring 2015**

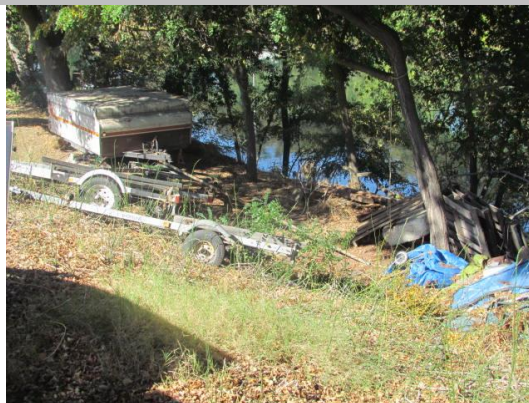
Photo 2 of 4 : SP\_2015\_RD0003\_24\_188\_20150309\_00079.jpg

LM Start	0.21	Rating **	M	Issue No.	188 (cont)
LM End	0.21	Issue Type +	En	Location *	WS
Category	Earthen Levee			GPS Latitude/Longitude	
				Start	End
Item	Encroachments			38.302625 °	38.302625 °
				-121.577683 °	-121.577683 °
DWR ID	DWR_RD0003_01_s_2012_188				
Action/Comments					
Garbage					
Inspector Comments: Landowner has piled wooden boards and trash on waterside berm.

Looking southwest at garbage and equipment on waterward berm. (Fall 2014)

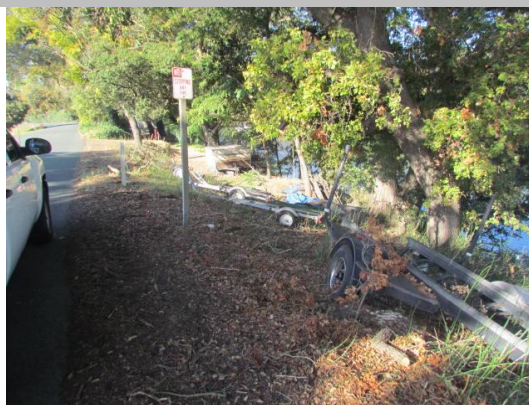
Photo 3 of 4 : SP\_2015\_RD0003\_24\_188\_20150309\_00080.jpg

Looking southwest at equipment and garbage stored on waterward slope and toe. (Spring 2014)

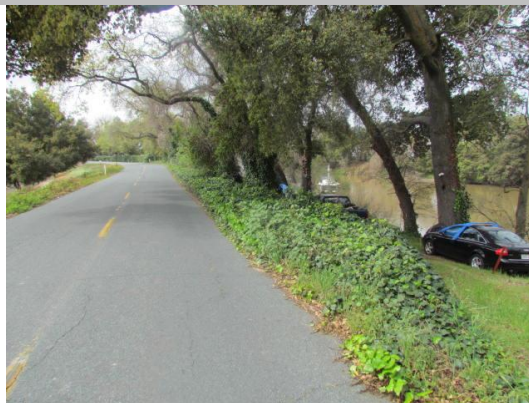
Photo 1 of 1 : SP\_2015\_RD0003\_24\_6\_20150309\_00006.jpg

LM Start	0.22	Rating **	U	Issue No.	6
LM End	0.33	Issue Type +	En	Location *	WS
Category	Earthen Levee			GPS Latitude/Longitude	
				Start	End
Item	Vegetation			38.302530 °	38.301424 °
				-121.577848 °	-121.579113 °
DWR ID	DWR_RD0003_01_s _ 2012_6				
Action/Comments					
Landscaping

Looking southwest at landscaping on waterside shoulder and slope.

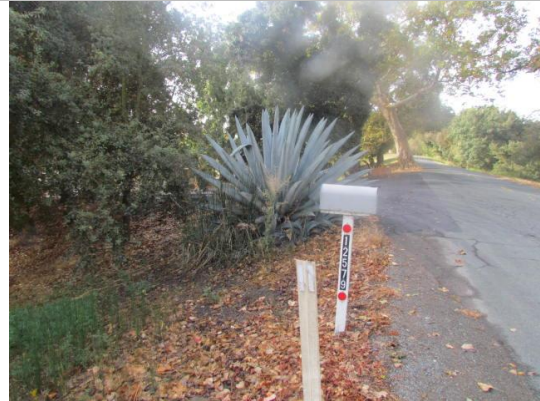
Photo 2 of 2 : SP\_2015\_RD0003\_24\_22\_20150309\_00024.jpg

LM Start	0.46	Rating **	M	Issue No.	22 (cont)
LM End	0.46	Issue Type +	En	Location *	LS
Category	Earthen Levee			GPS Latitude/Longitude	
				Start	End
Item	Vegetation			38.299690 °	38.299690 °
				-121.579959 °	-121.579959 °
DWR ID	DWR_RD0003_01_f_2012_22				
Action/Comments					
Landscaping					
Inspector Comments: Century plant on landward shoulder.

Looking southeast at century plant on landside shoulder.(Spring 2014)

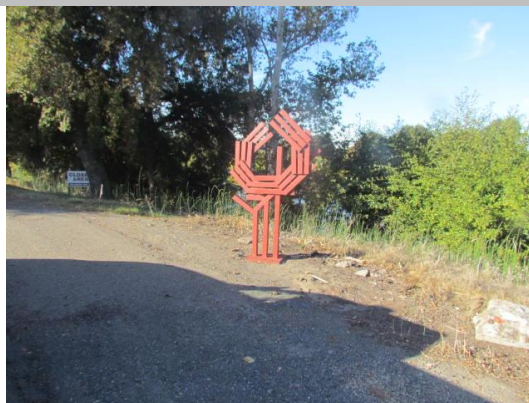
Photo 1 of 1 : SP\_2015\_RD0003\_24\_132\_20150309\_00077.jpg

LM Start	1.04	Rating **	M	Issue No.	132
LM End	1.04	Issue Type +	En	Location *	WS
Category	Earthen Levee			GPS Latitude/Longitude	
				Start	End
Item	Encroachments			38.291528 °	38.291528 °
				-121.582767 °	-121.582767 °
DWR ID	DWR_RD0003_01_f_2014_132				
Action/Comments					
Sign					
Inspector Comments: Unauthorized sign on waterward should.

Looking southwest at sign on waterward shoulder.

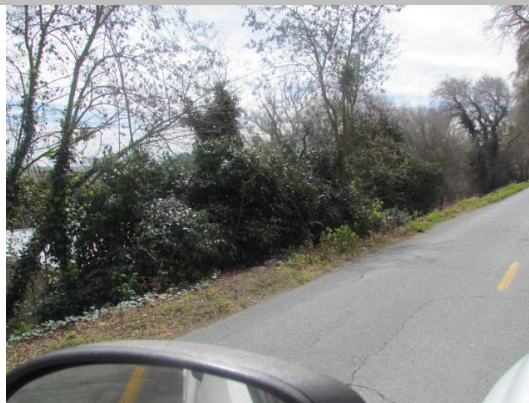
Photo 2 of 2 : SP\_2015\_RD0003\_24\_12\_20150309\_00012.jpg

LM Start	1.07	Rating **	U	Issue No.	12 (cont)
LM End	1.08	Issue Type +	En	Location *	LS
Category	Earthen Levee			GPS Latitude/Longitude	
				Start	End
Item	Vegetation			38.291055 °	38.290898 °
				-121.582765 °	-121.582777 °
DWR ID	DWR_RD0003_01_s_2012_12				
Action/Comments					
Landscaping

Looking southeast at landscaping on landside slope.

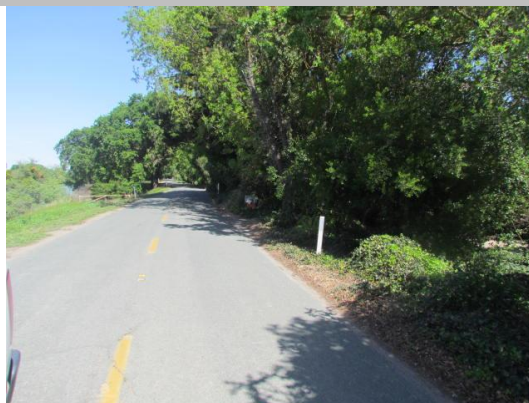
Photo 1 of 2 : SP\_2015\_RD0003\_24\_21\_20150309\_00021.jpg

LM Start	1.21	Rating **	U	Issue No.	21
LM End	1.26	Issue Type +	En	Location *	LS
Category	Earthen Levee			GPS Latitude/Longitude	
				Start	End
Item	Vegetation			38.289130 °	38.288327 °
				-121.582800 °	-121.582822 °
DWR ID	DWR_RD0003_01_s_2013_21				
Action/Comments					
Landscaping					
Inspector Comments: Landscaping has in place for several years.

Looking north at dense landscaping on landward shoulder and slope.

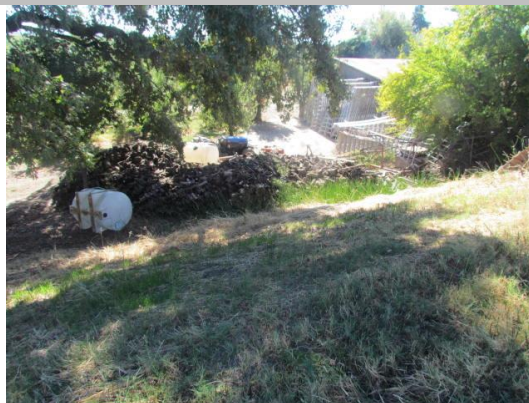
Photo 1 of 3 : SP\_2015\_RD0003\_24\_33\_20150309\_00039.jpg

Looking east at firewood on landward toe. (Fall 2014)

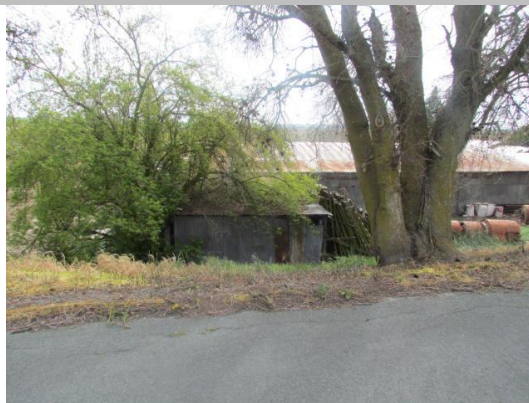
Photo 2 of 3 : SP\_2015\_RD0003\_24\_33\_20150309\_00040.jpg

Looking east at tool shed and equipment on landside toe.

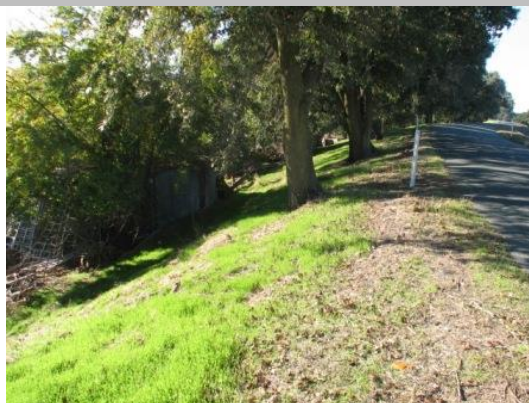
Photo 3 of 3 : SP\_2015\_RD0003\_24\_33\_20150309\_00041.jpg

Equipment within 10' of levee toe obstructs access and visibility.

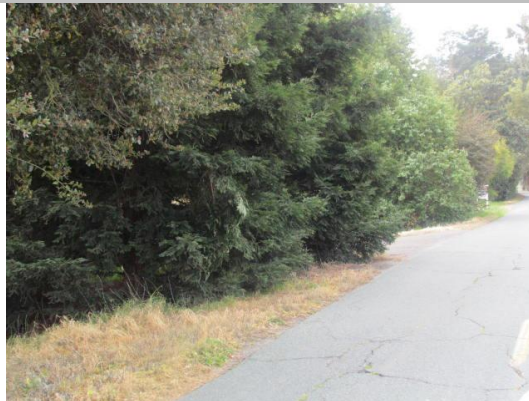
Photo 1 of 2 : SP\_2015\_RD0003\_24\_15\_20150309\_00015.jpg

LM Start	1.59	Rating **	U	Issue No.	15
LM End	1.59	Issue Type +	En	Location *	LS
Category	Earthen Levee			GPS Latitude/Longitude	
				Start	End
Item	Vegetation			38.284777 °	38.284777 °
				-121.586340 °	-121.586340 °
DWR ID	DWR_RD0003_01_s _ 2012_15				
Action/Comments					
Landscaping					
Inspector Comments: Large redwood trees on landward shoulder.

Looking southeast at dense trees on landside shoulder and slope.  
(updated Spring 2012)

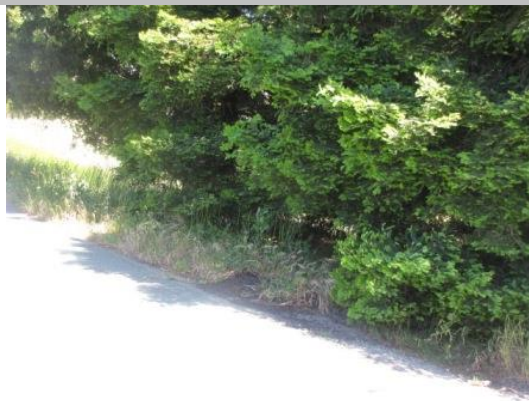
Photo 2 of 2 : SP\_2015\_RD0003\_24\_15\_20150309\_00016.jpg

Looking southeast at dense trees on landside shoulder and slope.

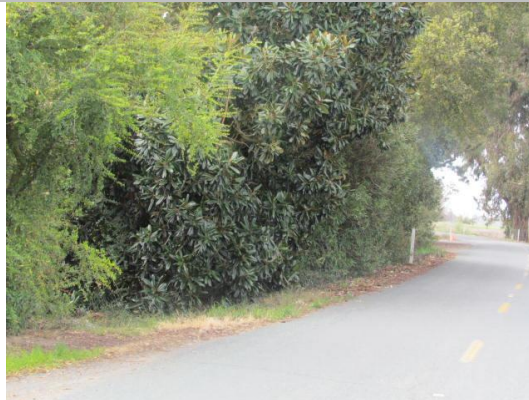
Photo 1 of 1 : SP\_2015\_RD0003\_24\_7\_20150309\_00007.jpg

LM Start	1.60	Rating **	U	Issue No.	7
LM End	1.60	Issue Type +	En	Location *	LS
Category	Earthen Levee			GPS Latitude/Longitude	
				Start	End
Item	Vegetation			38.284645 °	38.284645 °
				-121.586534 °	-121.586534 °
DWR ID	DWR_RD0003_01_s _ 2012_7				
Action/Comments					
Landscaping

Looking south at dense landscaping on landside shoulder and slope.

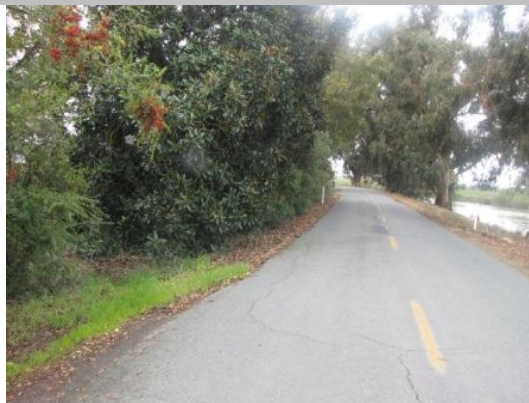
Photo 1 of 1 : SP\_2015\_RD0003\_24\_16\_20150309\_00017.jpg

LM Start	1.61	Rating **	U	Issue No.	16
LM End	1.65	Issue Type +	En	Location *	LS
Category	Earthen Levee			GPS Latitude/Longitude	
				Start	End
Item	Vegetation			38.284574 °	38.284177 °
				-121.586631 °	-121.587208 °
DWR ID	DWR_RD0003_01_s _ 2012_16				
Action/Comments					
Landscaping

Looking southwest at dense landscaping on landside shoulder and slope.

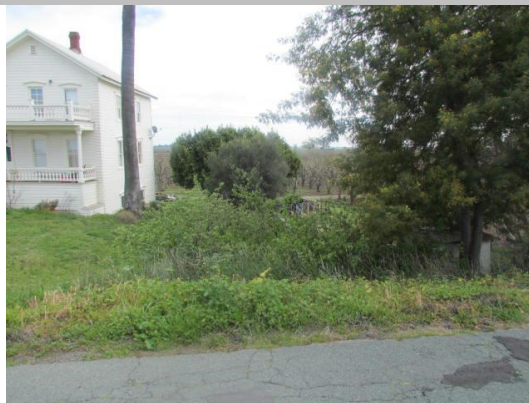
Photo 1 of 1 : SP\_2015\_RD0003\_24\_8\_20150309\_00008.jpg

Looking east at vegetation on landside slope.

LM Start	1.76	Rating **	M	Issue No.	8
LM End	1.76	Issue Type +	Ma	Location *	LS
Category	Earthen Levee			GPS Latitude/Longitude	
				Start	End
Item	Vegetation			38.282771 °	38.282771 °
				-121.588227 °	-121.588227 °
DWR ID	DWR_RD0003_01_s _ 2012_8				
Action/Comments					
Remove the wild growth other than native grasses from the levee slopes.

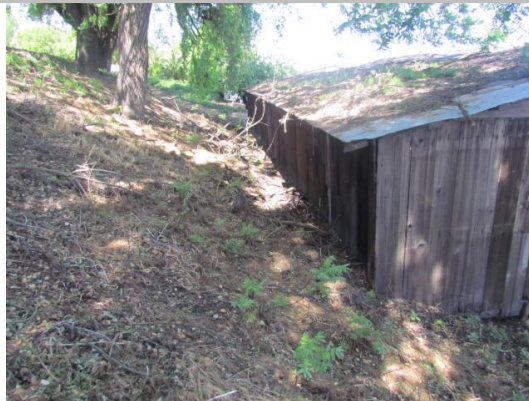
Photo 1 of 2 : SP\_2015\_RD0003\_24\_28\_20150309\_00034.jpg

LM Start	2.41	Rating **	U	Issue No.	28
LM End	2.41	Issue Type +	En	Location *	LS
Category	Earthen Levee			GPS Latitude/Longitude	
				Start	End
Item	Encroachments			38.274468 °	38.274468 °
				-121.587852 °	-121.587852 °
DWR ID	DWR_RD0003_01_s _ 2013_28				
Action/Comments					
Building					
Inspector Comments: Storage shed at landside toe.

Looking north at storage shed at landward toe.

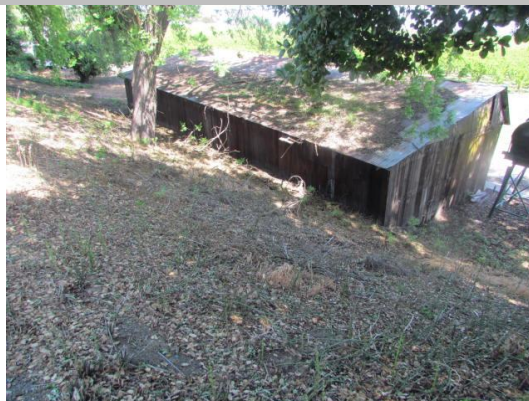
Photo 2 of 2 : SP\_2015\_RD0003\_24\_28\_20150309\_00035.jpg

Looking northeast at storage shed at landward toe.

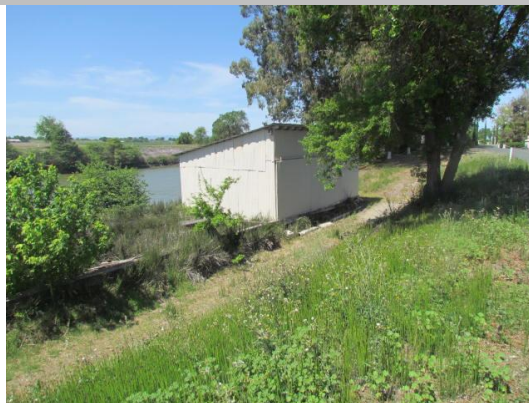
Photo 1 of 1 : SP\_2015\_RD0003\_24\_48\_20150309\_00046.jpg

LM Start	2.87	Rating **	U	Issue No.	48
LM End	2.87	Issue Type +	En	Location *	WS
Category	Earthen Levee			GPS Latitude/Longitude	
				Start	End
Item	Encroachments			38.268257 °	38.268257 °
				-121.587677 °	-121.587677 °
DWR ID	DWR_RD0003_01_s_2013_48				
Action/Comments					
Building					
Inspector Comments: Storage shed has been here for several years on waterward berm. Storage shed appears to be abandoned and should be removed.

Looking northwest at storage shed on waterward berm.

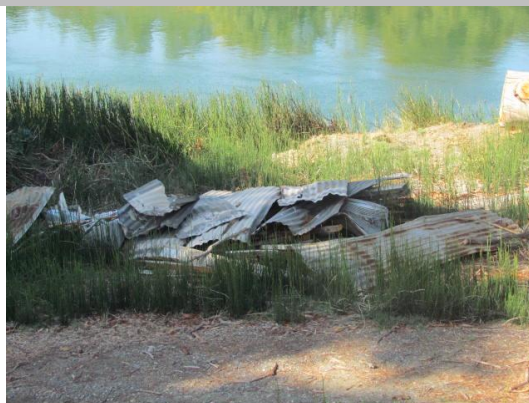
Photo 1 of 1 : SP\_2015\_RD0003\_24\_105\_20150309\_00074.jpg

LM Start	2.89	Rating **	A/W	Issue No.	105
LM End	2.89	Issue Type +	Ma	Location *	WS
Category	Earthen Levee			GPS Latitude/Longitude	
				Start	End
Item	Encroachments				◦
					◦
DWR ID	DWR_RD0003_01_f_2013_105				
Action/Comments					
Garbage Inspector Comments: Tin roofing material on waterward berm.

Looking west at tin roofing material on waterward berm.

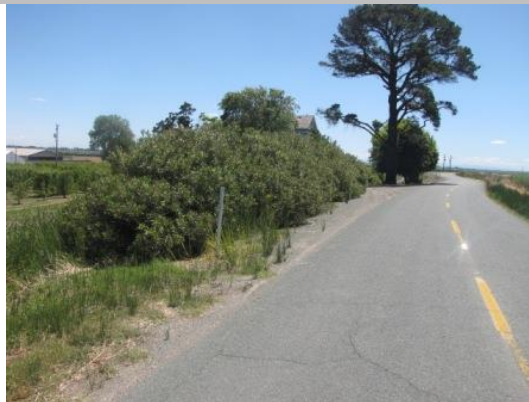
Photo 1 of 1 : SP\_2015\_RD0003\_24\_20\_20150309\_00020.jpg

LM Start	3.11	Rating **	M	Issue No.	20
LM End	3.13	Issue Type +	En	Location *	LS
Category	Earthen Levee			GPS Latitude/Longitude	
				Start	End
Item	Vegetation			38.264902 °	38.264580 °
				-121.587193 °	-121.587220 °
DWR ID	DWR_RD0003_01_s_2012_20				
Action/Comments					
Landscaping					
Inspector Comments: Oleander on landside shoulder.

Looking northeast at dense veg. on landside slope.

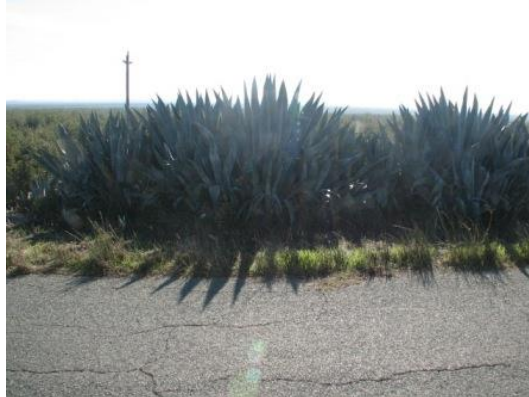
Photo 2 of 2 : SP\_2015\_RD0003\_24\_51\_20150309\_00049.jpg

Large cactus on upper levee slope obstructs access and visibility.

LM Start	3.30	Rating **	A/W	Issue No.	51 (cont)
LM End	3.30	Issue Type +	Ma	Location *	LS
Category	Earthen Levee			GPS Latitude/Longitude	
				Start	End
Item	Vegetation			38.262289 °	38.262289 °
				-121.588250 °	-121.588250 °
DWR ID	DWR_RD0003_01_s _ 2012_51				
Action/Comments					
Remove the wild growth other than native grasses from the levee slopes.					
Inspector Comments: Cactus

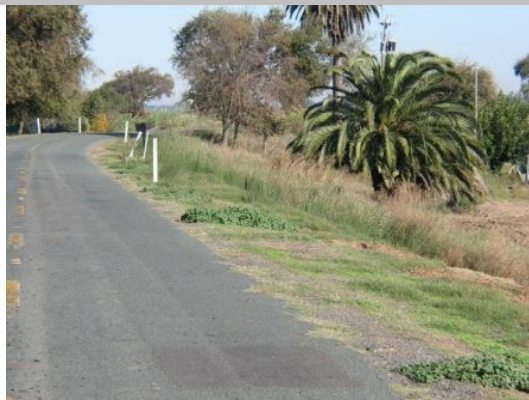
Photo 1 of 1 : SP\_2015\_RD0003\_24\_57\_20150309\_00050.jpg

Vegetation on levee slopes and toe partially obstruct visibility.

LM Start	4.27	Rating **	A/W	Issue No.	57
LM End	4.46	Issue Type +	Ma	Location *	LS
Category	Earthen Levee			GPS Latitude/Longitude	
				Start	End
Item	Vegetation			38.253800 °	38.251824 °
				-121.599100 °	-121.600980 °
DWR ID	DWR_RD0003_01_s _ 2012_57				
Action/Comments					
Remove the wild growth other than native grasses from the levee slopes.

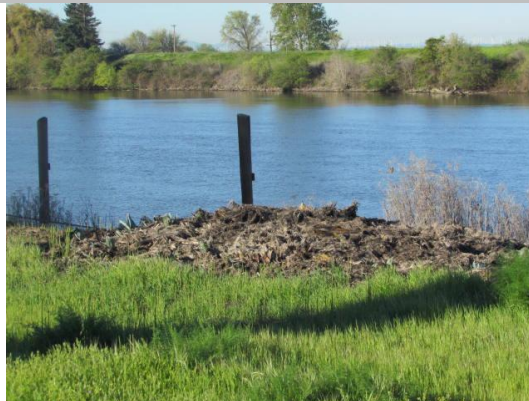
Photo 1 of 2 : SP\_2015\_RD0003\_24\_60\_20150309\_00051.jpg

Looking west at mowed/removed century plant on waterward slope.

LM Start	5.08	Rating **	A/W	Issue No.	60
LM End	5.08	Issue Type +	Ma	Location *	WS
Category	Earthen Levee			GPS Latitude/Longitude	
				Start	End
Item	Vegetation			38.242873 °	38.242873 °
				-121.600817 °	-121.600817 °
DWR ID	DWR_RD0003_01_s _ 2013_60				
Action/Comments					
Remove the wild growth other than native grasses from the levee slopes.					
Inspector Comments: Century plant on waterward slope.

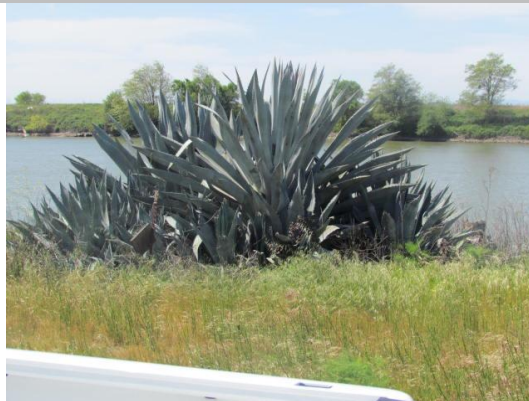
Photo 2 of 2 : SP\_2015\_RD0003\_24\_60\_20150309\_00052.jpg

Looking west at century plant on waterward slope.

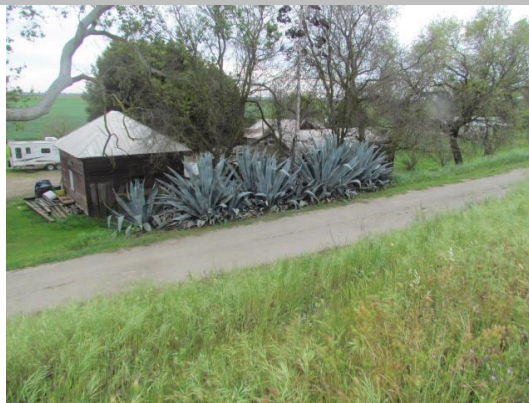
Photo 1 of 2 : SP\_2015\_RD0003\_24\_61\_20150318\_00100.jpg

Looking northwest at century plants on landside slope next to ramp.

LM Start	5.29	Rating **	U	Issue No.	61
LM End	5.29	Issue Type +	Ma	Location *	LS
Category	Earthen Levee			GPS Latitude/Longitude	
				Start	End
Item	Vegetation			38.239886 °	38.239886 °
				-121.601752 °	-121.601752 °
DWR ID	DWR_RD0003_01_s _ 2012_61				
Action/Comments					
Remove the wild growth other than native grasses from the levee slopes.					
Inspector Comments: Century plant on landside slope next to ramp.

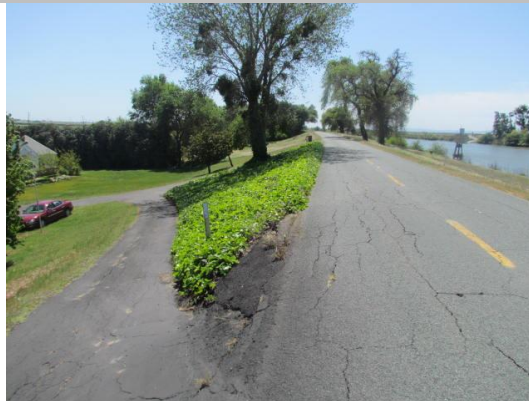
Photo 1 of 1 : SP\_2015\_RD0003\_24\_43\_20150309\_00043.jpg

LM Start	5.33	Rating **	M	Issue No.	43
LM End	5.36	Issue Type +	En	Location *	LS
Category	Earthen Levee			GPS Latitude/Longitude	
				Start	End
Item	Vegetation			38.239276 °	38.238852 °
				-121.601899 °	-121.602000 °
DWR ID	DWR_RD0003_01_s _ 2012_43				
Action/Comments					
Landscaping

Looking southeast at ground cover on landward slope.

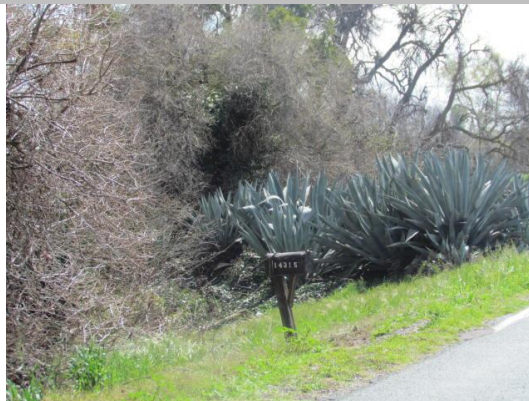
Photo 1 of 1 : SP\_2015\_RD0003\_24\_44\_20150309\_00044.jpg

LM Start	5.45	Rating **	U	Issue No.	44
LM End	5.52	Issue Type +	En	Location *	LS
Category	Earthen Levee			GPS Latitude/Longitude	
				Start	End
Item	Vegetation			38.237690 °	38.236575 °
				-121.602231 °	-121.602155 °
DWR ID	DWR_RD0003_01_s _ 2012_44				
Action/Comments					
Landscaping					
Inspector Comments: Large century plants.

Looking southeast at century plants on landside shoulder and slope.

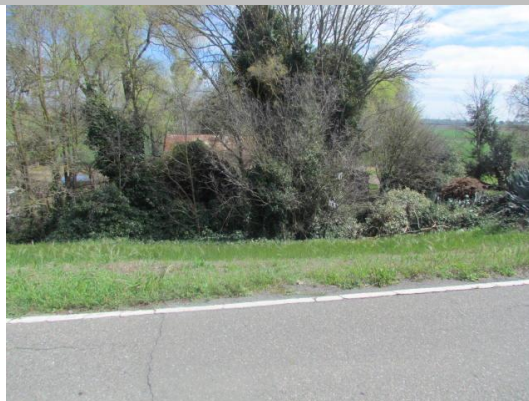
Photo 1 of 1 : SP\_2015\_RD0003\_24\_45\_20150309\_00045.jpg

LM Start	5.49	Rating **	M	Issue No.	45
LM End	5.49	Issue Type +	En	Location *	LS
Category	Earthen Levee			GPS Latitude/Longitude	
				Start	End
Item	Vegetation			38.237000 °	38.237000 °
				-121.602208 °	-121.602208 °
DWR ID	DWR_RD0003_01_s _ 2012_45				
Action/Comments					
Landscaping

Looking east at landscaping on landside toe.

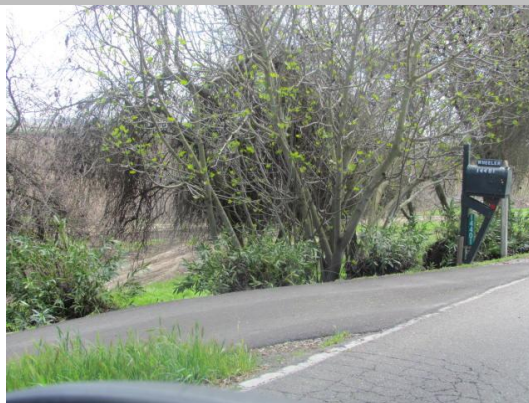
Photo 1 of 2 : SP\_2015\_RD0003\_24\_64\_20150309\_00054.jpg

LM Start	5.72	Rating **	A/W	Issue No.	64
LM End	5.72	Issue Type +	En	Location *	LS
Category	Earthen Levee			GPS Latitude/Longitude	
				Start	End
Item	Vegetation			38.233767 °	38.233767 °
				-121.601469 °	-121.601469 °
DWR ID	DWR_RD0003_01_s _ 2012_64				
Action/Comments					
Landscaping					
Inspector Comments: Landowner trimmed landscaping.

Looking southeast at trimmed landscaping on landside shoulder and slope. (Updated Spring 2012)

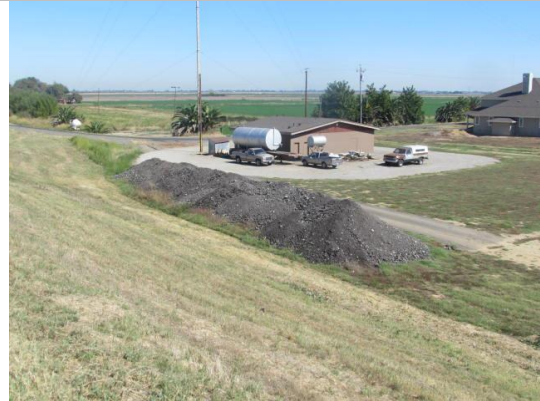
Photo 1 of 1 : SP\_2015\_RD0003\_24\_131\_20150309\_00076.jpg

LM Start	6.02	Rating **	M	Issue No.	131
LM End	6.02	Issue Type +	En	Location *	LS
Category	Earthen Levee			GPS Latitude/Longitude	
				Start	End
Item	Encroachments			38.229436 °	38.229436 °
				-121.601700 °	-121.601700 °
DWR ID	DWR_RD0003_01_f_2014_131				
Action/Comments					
Material					
Inspector Comments: Landowner stockpiling asphalt at landside toe.

Looking northeast at asphalt stockpile at landward toe.

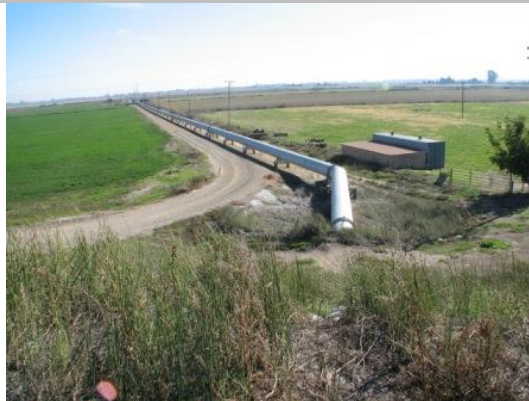
Photo 1 of 1 : SP\_2015\_RD0003\_24\_69\_20150309\_00056.jpg

LM Start	6.71	Rating **	A/W	Issue No.	69
LM End	6.71	Issue Type +	En	Location *	LS
Category	Earthen Levee			GPS Latitude/Longitude	
				Start	End
Item	Encroachments			38.219603 °	38.219603 °
				-121.601767 °	-121.601767 °
DWR ID	DWR_RD0003_01_s _ 2012_69				
Action/Comments					
Pipe					
Inspector Comments: Drainage pipe crossing

Interior drainage discharge pipe penetrates levee.

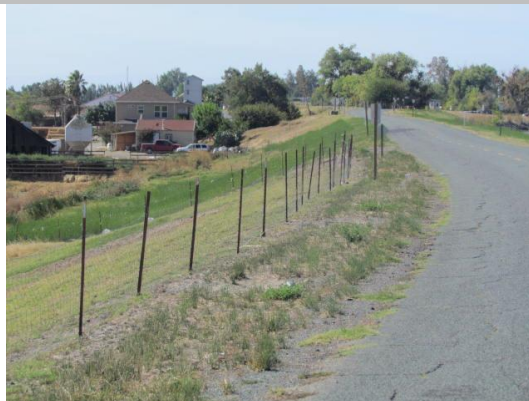
Photo 1 of 1 : SP\_2015\_RD0003\_24\_106\_20150309\_00075.jpg

LM Start	6.83	Rating **	M	Issue No.	106
LM End	6.90	Issue Type +	En	Location *	LS
Category	Earthen Levee			GPS Latitude/Longitude	
				Start	End
Item	Encroachments				°
					°
DWR ID	DWR_RD0003_01_f _ 2013_106				
Action/Comments					
Fence					
Inspector Comments: Fencing on landward shoulder.

Looking southeast at fencing on landward shoulder and slope.

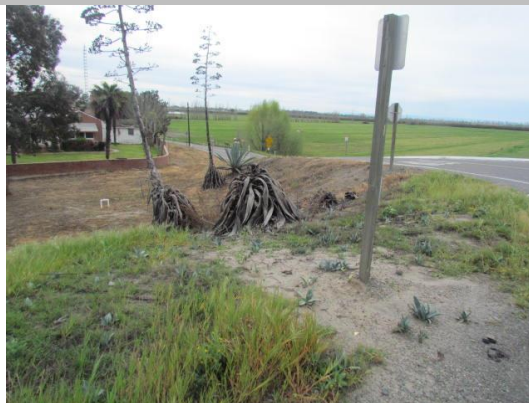
Photo 1 of 4 : SP\_2015\_RD0003\_24\_23\_20150318\_00101.jpg

LM Start	7.04	Rating **	A/W	Issue No.	23
LM End	7.05	Issue Type +	En	Location *	LS
Category	Earthen Levee			GPS Latitude/Longitude	
				Start	End
Item	Vegetation			38.215490 °	38.215355 °
				-121.604700 °	-121.604793 °
DWR ID	DWR_RD0003_01_s _ 2012_23				
Action/Comments					
Landscaping					
Inspector Comments: Remove century plant on landside shoulder and slope. Landowner removed all century plants expect for three plants.

Looking southeast at dead century plants on landward slope. (Spring 2015)

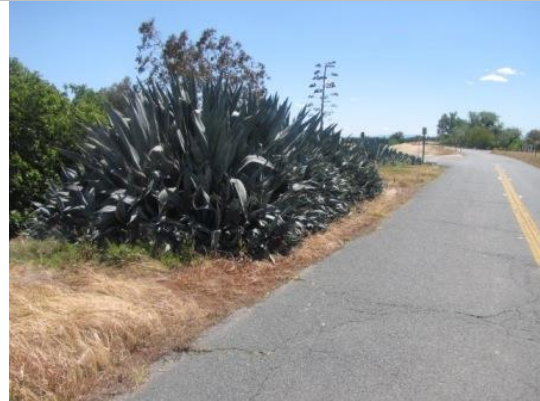
Photo 3 of 4 : SP\_2015\_RD0003\_24\_23\_20150309\_00026.jpg

LM Start	7.04	Rating **	A/W	Issue No.	23 (cont)
LM End	7.05	Issue Type +	En	Location *	LS
Category	Earthen Levee			GPS Latitude/Longitude	
				Start	End
Item	Vegetation			38.215490 °	38.215355 °
				-121.604700 °	-121.604793 °
DWR ID	DWR_RD0003_01_s _ 2012_23				
Action/Comments					
Landscaping					
Inspector Comments: Remove century plant on landside shoulder and slope. Landowner removed all century plants expect for three plants.

Looking northeast at updated picture (5/2010) of century plants on landside shoulder and slope.

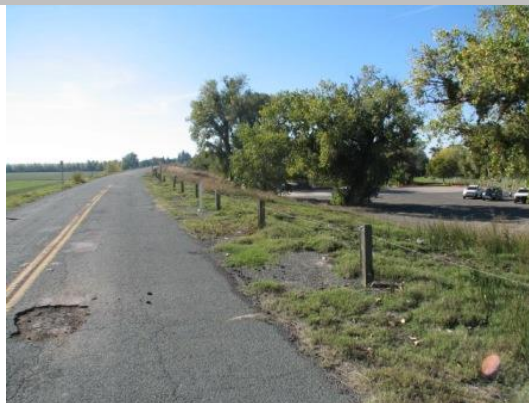
Photo 1 of 1 : SP\_2015\_RD0003\_24\_72\_20150309\_00057.jpg

LM Start	7.17	Rating **	A/W	Issue No.	72
LM End	7.44	Issue Type +	En	Location *	WS
Category	Earthen Levee			GPS Latitude/Longitude	
				Start	End
Item	Vegetation			38.213785 °	38.210179 °
				-121.605671 °	-121.607686 °
DWR ID	DWR_RD0003_01_s_2012_72				
Action/Comments					
Remove the wild growth other than native grasses from the levee slopes.					
Inspector Comments: Vegetation near boat launch obstructs visibility.

Vegetation on levee slope near boat launch is partially obstructive.

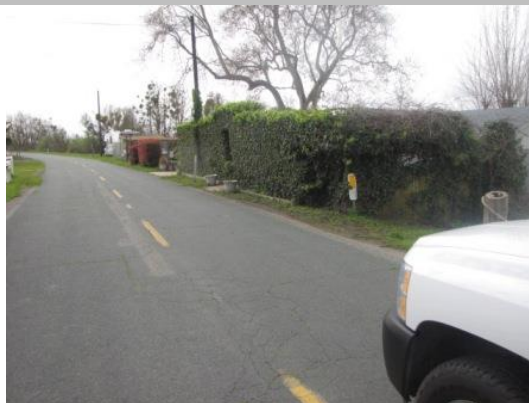
Photo 1 of 1 : SP\_2015\_RD0003\_24\_75\_20150309\_00059.jpg

LM Start	7.64	Rating **	U	Issue No.	75
LM End	7.64	Issue Type +	En	Location *	WS
Category	Earthen Levee			GPS Latitude/Longitude	
				Start	End
Item	Vegetation			38.207640 °	38.207640 °
				-121.609334 °	-121.609334 °
DWR ID	DWR_RD0003_01_s _ 2012_75				
Action/Comments					
Landscaping

Looking southwest at landscaping in front of a house on waterside berm.  
Also not in the picture a building on landside berm.

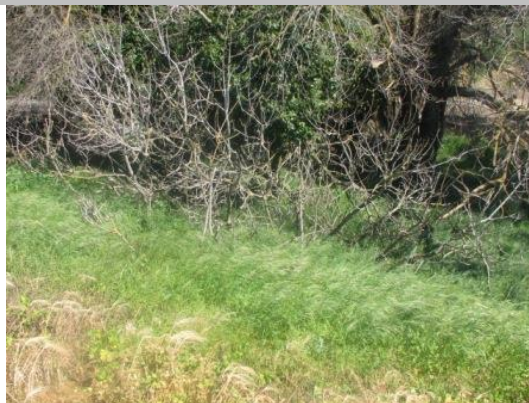
Photo 2 of 2 : SP\_2015\_RD0003\_24\_971\_20150309\_00083.jpg

LM Start	7.75	Rating **	A/W	Issue No.	971 (cont)	
LM End	7.77	Issue Type +	En	Location *	WS	
Category	Earthen Levee			GPS Latitude/Longitude		
				Start		End
Item	Vegetation			38.205964 °		38.205733 °
				-121.609576 °		-121.609608 °
DWR ID	DWR_RD0003_01_s _ 2012_971					
Action/Comments						
Landscaping

Front view of dense trees at landside toe.

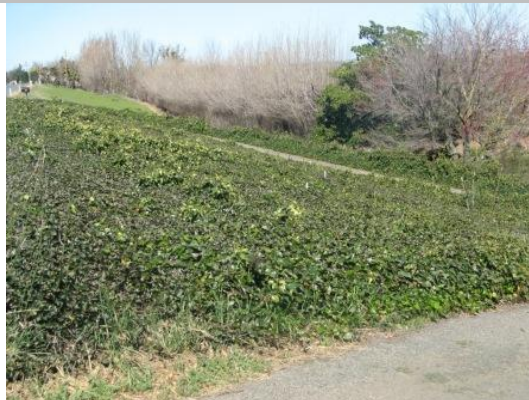
Photo 1 of 1 : SP\_2015\_RD0003\_24\_25\_20150309\_00029.jpg

LM Start	7.89	Rating **	U	Issue No.	25
LM End	7.94	Issue Type +	En	Location *	LS
Category	Earthen Levee			GPS Latitude/Longitude	
				Start	End
Item	Vegetation			38.203945 °	38.203283 °
				-121.609932 °	-121.610025 °
DWR ID	DWR_RD0003_01_s_2012_25				
Action/Comments					
Landscaping

Landscaping (Ivy) on landside slope blocking view of levee from LM 7.95 to 8.00

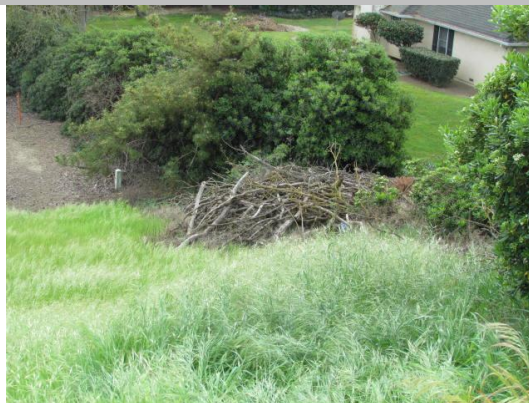
Photo 1 of 1 : SP\_2015\_RD0003\_24\_94\_20150318\_00102.jpg

LM Start	8.39	Rating **	M	Issue No.	94
LM End	8.39	Issue Type +	Ma	Location *	LS
Category	Earthen Levee			GPS Latitude/Longitude	
				Start	End
Item	Encroachments			38.197202 °	38.197202 °
				-121.612962 °	-121.612962 °
DWR ID	DWR_RD0003_01_s _ 2013_94				
Action/Comments					
Prunings					
Inspector Comments: Prunings on landward slope.

Looking east at prunings on landward slope.

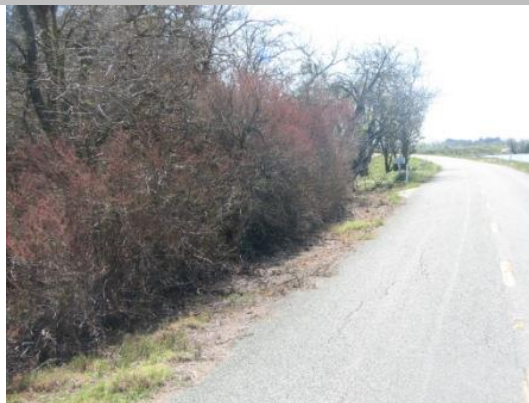
Photo 1 of 3 : SP\_2015\_RD0003\_24\_27\_20150309\_00031.jpg

LM Start	<b>10.12</b>	Rating **	A/W	Issue No.	<b>27 (cont)</b>
LM End	<b>10.14</b>	Issue Type +	En	Location *	LS

Trees to be trimmed on landside shoulder from LM 10.20 to 10.22

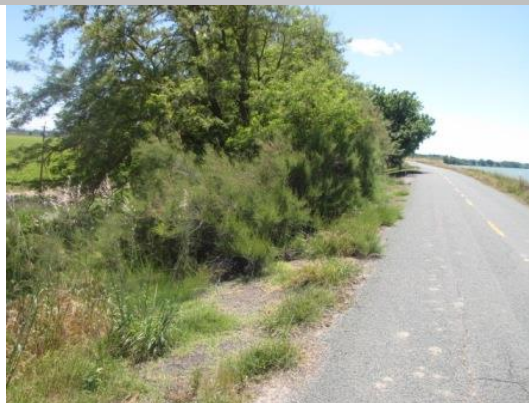
Photo 2 of 3 : SP\_2015\_RD0003\_24\_27\_20150309\_00032.jpg

Looking north at updated picture (5/10) of dense trees on landside slope.

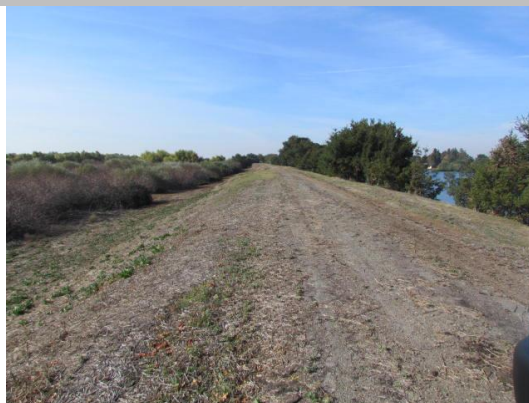
Photo 1 of 1 : SP\_2015\_RD0003\_24\_92\_20150309\_00062.jpg

LM Start	10.79	Rating **	A/W	Issue No.	92
LM End	10.92	Issue Type +	En	Location *	LS
Category	Earthen Levee			GPS Latitude/Longitude	
				Start	End
Item	Vegetation			38.183204 °	38.182481 °
				-121.650861 °	-121.653199 °
DWR ID	DWR_RD0003_01_s _ 2015_92				
Action/Comments					
Remove the wild growth other than native grasses from the levee slopes.					
Inspector Comments: Photo of obstructive vegetation beyond levee mile 10.87

Looking south at typical view of levee between levee mile 10.87 to 11.01

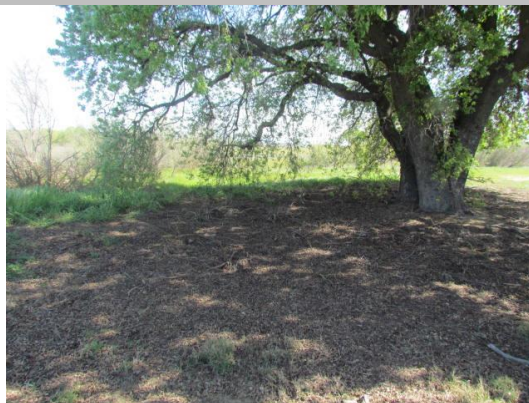
Photo 1 of 1 : SP\_2015\_RD0003\_25\_4\_20150318\_00087.jpg

LM Start	0.25	Rating **	M	Issue No.	4
LM End	0.25	Issue Type +	Ma	Location *	LS
Category	Earthen Levee			GPS Latitude/Longitude	
				Start	End
Item	Trim / Thin Trees			38.174504 °	38.174504 °
				-121.649651 °	-121.649651 °
DWR ID	DWR_RD0003_02_s_2012_4				
Action/Comments					
Thin trees to allow visibility of the ground and room to flood fight.

Looking west at untrimmed tree on landward shoulder.

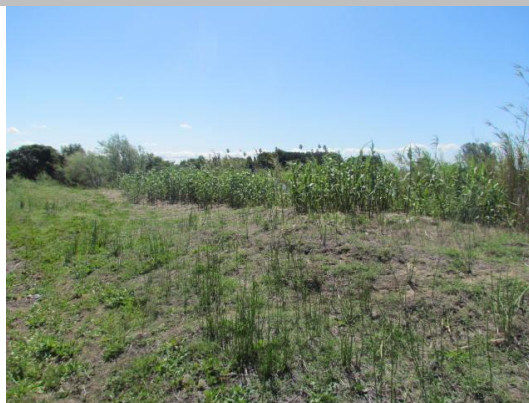
Photo 1 of 2 : SP\_2015\_RD0003\_25\_5\_20150309\_00006.jpg

LM Start	0.30	Rating **	M	Issue No.	5
LM End	0.32	Issue Type +	Ma	Location *	WS
Category	Earthen Levee			GPS Latitude/Longitude	
				Start	End
Item	Vegetation			38.174281 °	38.174209 °
				-121.648698 °	-121.648352 °
DWR ID	DWR_RD0003_02_s_2012_5				
Action/Comments					
Remove the wild growth other than native grasses from the levee slopes.					
Inspector Comments: New sprouts of bamboo.

Looking northeast at the new sprouting of bamboo on waterward slope.

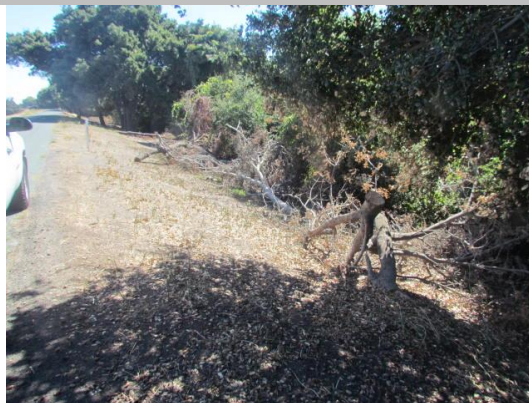
Photo 1 of 1 : SP\_2015\_RD0003\_25\_154\_20150309\_00080.jpg

LM Start	1.50	Rating **	M	Issue No.	154
LM End	1.50	Issue Type +	Ma	Location *	WS
Category	Earthen Levee			GPS Latitude/Longitude	
				Start	End
Item	Encroachments			38.169204 °	38.169204 °
				-121.628268 °	-121.628268 °
DWR ID	DWR_RD0003_02_f_2014_154				
Action/Comments					
Tree or limb					
Inspector Comments: Downed tree limbs on waterward slope.

Looking northeast at tree limbs on waterward slope.

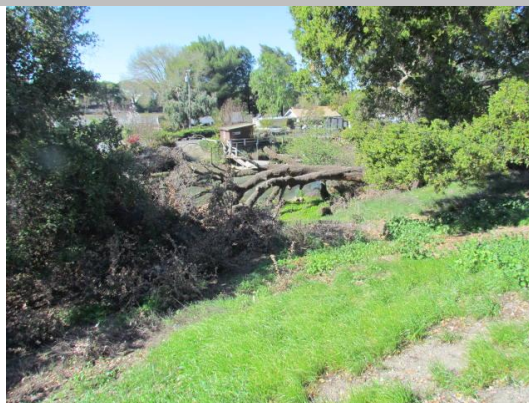
Photo 1 of 2 : SP\_2015\_RD0003\_25\_104\_20150309\_00078.jpg

LM Start	1.57	Rating **	M	Issue No.	104
LM End	1.57	Issue Type +	Ma	Location *	WS
Category	Earthen Levee			GPS Latitude/Longitude	
				Start	End
Item	Encroachments			38.168662 °	38.168662 °
				-121.627167 °	-121.627167 °
DWR ID	DWR_RD0003_02_s_2014_104				
Action/Comments					
Prunings

Looking southeast at downed tree on waterward slope.

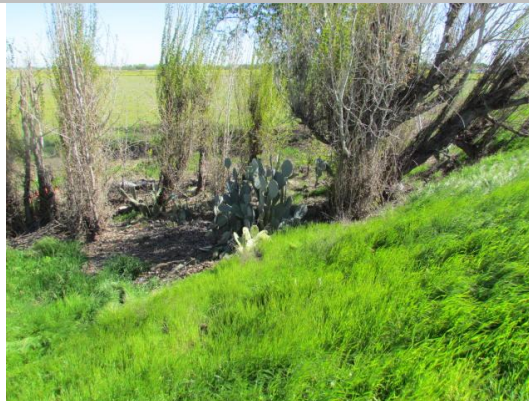
Photo 1 of 2 : SP\_2015\_RD0003\_25\_30\_20150309\_00029.jpg

LM Start	2.44	Rating **	M	Issue No.	30
LM End	2.44	Issue Type +	En	Location *	LS
Category	Earthen Levee			GPS Latitude/Longitude	
				Start	End
Item	Vegetation			38.164379 °	38.164379 °
				-121.612455 °	-121.612455 °
DWR ID	DWR_RD0003_02_f_2013_30				
Action/Comments					
Landscaping					
Inspector Comments: Cactus at landward toe and berm.

Looking northwest at cactus on landward toe.

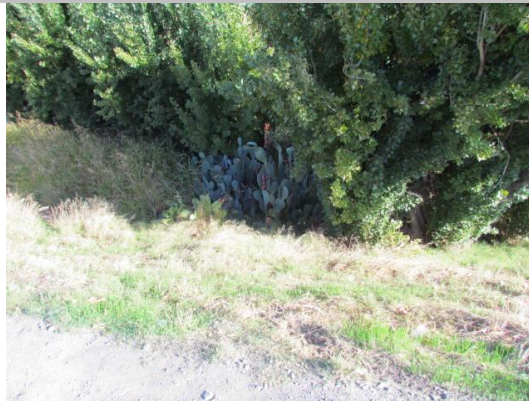
Photo 2 of 2 : SP\_2015\_RD0003\_25\_30\_20150309\_00030.jpg

LM Start	<b>2.44</b>	Rating **	M	Issue No.	<b>30 (cont)</b>
LM End	<b>2.44</b>	Issue Type +	En	Location *	LS

Looking west at cactus on landward toe.

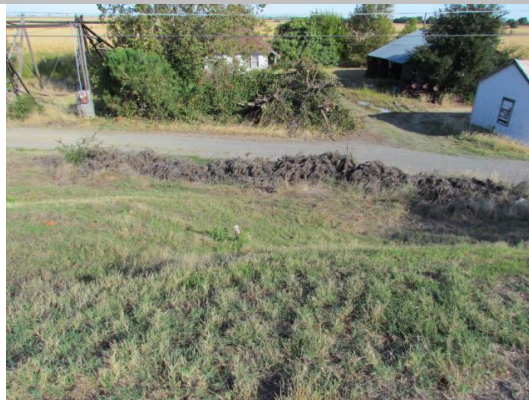
Photo 1 of 1 : SP\_2015\_RD0003\_25\_96\_20150309\_00070.jpg

LM Start	2.80	Rating **	M	Issue No.	96
LM End	2.80	Issue Type +	En	Location *	LS
Category	Earthen Levee			GPS Latitude/Longitude	
				Start	End
Item	Encroachments			38.164945 °	38.164945 °
				-121.605874 °	-121.605874 °
DWR ID	DWR_RD0003_02_f_2013_96				
Action/Comments					
Prunings					
Inspector Comments: Pruning piles at landward toe.

Looking west at pruning piles on landward toe.

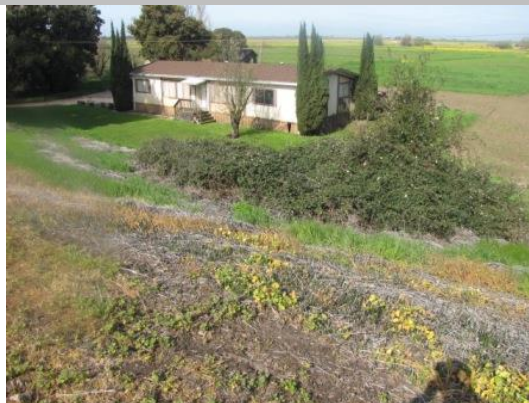
Photo 1 of 1 : SP\_2015\_RD0003\_25\_44\_20150309\_00037.jpg

LM Start	3.23	Rating **	A/W	Issue No.	44
LM End	3.23	Issue Type +	Ma	Location *	LS
Category	Earthen Levee			GPS Latitude/Longitude	
				Start	End
Item	Vegetation			38.168134 °	38.168134 °
				-121.599028 °	-121.599028 °
DWR ID	DWR_RD0003_02_s_2012_44				
Action/Comments					
Remove the wild growth other than native grasses from the levee slopes.					
Inspector Comments: Obstructive blackberry.

Looking west at berryvines on landside toe.

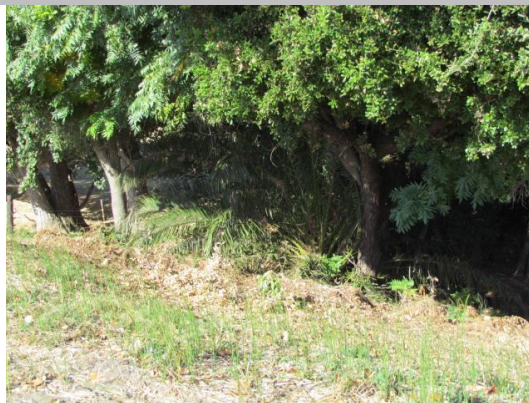
Photo 1 of 1 : SP\_2015\_RD0003\_25\_97\_20150309\_00071.jpg

LM Start	3.47	Rating **	M	Issue No.	97
LM End	3.47	Issue Type +	Ma	Location *	LS
Category	Earthen Levee			GPS Latitude/Longitude	
				Start	End
Item	Vegetation			38.170724 °	38.170724 °
				-121.596152 °	-121.596152 °
DWR ID	DWR_RD0003_02_f_2013_97				
Action/Comments					
Remove the wild growth other than native grasses from the levee slopes.					
Inspector Comments: Palm tree at landward toe.

Looking west at palm tree on landward toe.

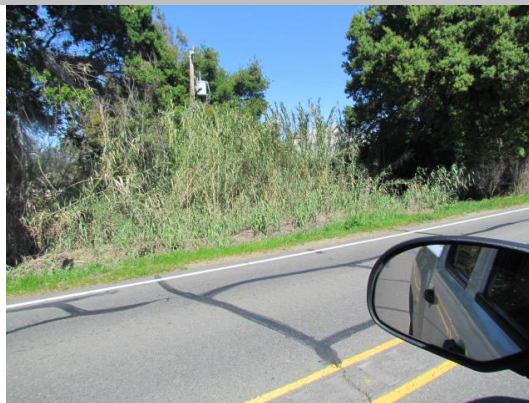
Photo 1 of 2 : SP\_2015\_RD0003\_25\_952\_20150309\_00084.jpg

LM Start	3.77	Rating **	M	Issue No.	952
LM End	3.77	Issue Type +	Ma	Location *	LS
Category	Earthen Levee			GPS Latitude/Longitude	
				Start	End
Item	Vegetation			38.174430 °	38.174430 °
				-121.593372 °	-121.593372 °
DWR ID	DWR_RD0003_02_s_2012_952				
Action/Comments					
Remove the wild growth other than native grasses from the levee slopes.					
Inspector Comments: Dense bamboo on landward slope.

Looking northwest at bamboo on landside slope.

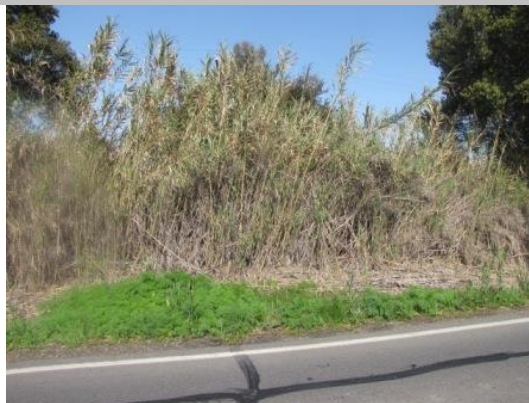
Photo 2 of 2 : SP\_2015\_RD0003\_25\_952\_20150309\_00085.jpg

LM Start	3.77	Rating **	M	Issue No.	952 (cont)
LM End	3.77	Issue Type +	Ma	Location *	LS
Category	Earthen Levee			GPS Latitude/Longitude	
				Start	End
Item	Vegetation			38.174430 °	38.174430 °
				-121.593372 °	-121.593372 °
DWR ID	DWR_RD0003_02_s _ 2012_952				
Action/Comments					
Remove the wild growth other than native grasses from the levee slopes.					
Inspector Comments: Dense bamboo on landward slope.

Looking west at dense bamboo on landside slope.

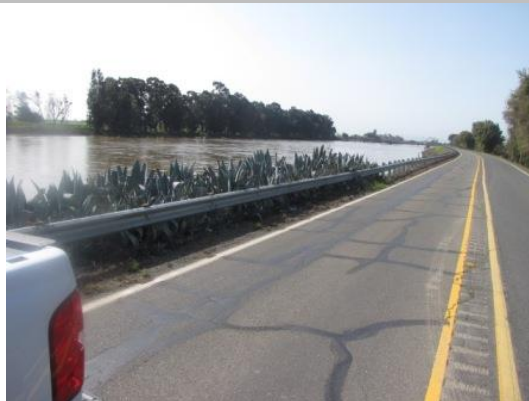
Photo 1 of 2 : SP\_2015\_RD0003\_25\_15\_20150309\_00019.jpg

LM Start	4.22	Rating **	M	Issue No.	15
LM End	4.22	Issue Type +	En	Location *	LS
Category	Earthen Levee			GPS Latitude/Longitude	
				Start	End
Item	Vegetation				°
					°
DWR ID	DWR_RD0003_02_s_2012_15				
Action/Comments					
Landscaping					
Inspector Comments: Cactus on landside and waterside slope

Looking southeast at cactus on waterside shoulder and slope.

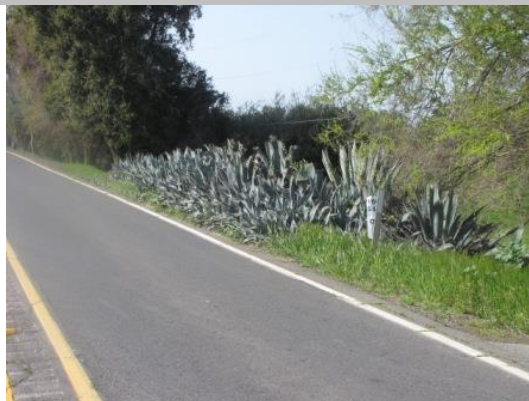
Photo 2 of 2 : SP\_2015\_RD0003\_25\_15\_20150309\_00020.jpg

Looking west at cactus on landside slope.

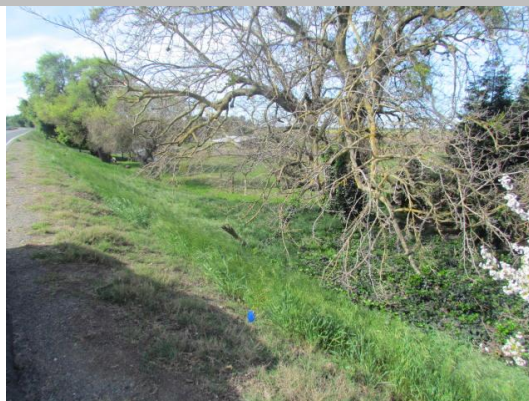
Photo 1 of 1 : SP\_2015\_RD0003\_25\_10\_20150318\_00091.jpg

LM Start	4.24	Rating **	M	Issue No.	10
LM End	4.24	Issue Type +	Ma	Location *	LS
Category	Earthen Levee			GPS Latitude/Longitude	
				Start	End
Item	Trim / Thin Trees			38.180361 °	38.180361 °
				-121.589127 °	-121.589127 °
DWR ID	DWR_RD0003_02_s_2012_10				
Action/Comments					
Trim trees to at least five feet above ground level.

Looking west at untrimmed tree on landward slope.

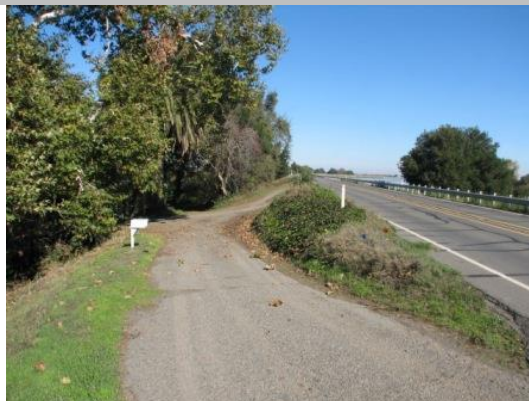
Photo 1 of 1 : SP\_2015\_RD0003\_25\_92\_20150309\_00069.jpg

LM Start	4.25	Rating **	M	Issue No.	92
LM End	4.32	Issue Type +	En	Location *	LS
Category	Earthen Levee			GPS Latitude/Longitude	
				Start	End
Item	Vegetation			38.180531 °	38.181330 °
				-121.589103 °	-121.588480 °
DWR ID	DWR_RD0003_02_s _ 2012_92				
Action/Comments					
Landscaping

Landscaping on levee slope and toe obstructs access and visibility.

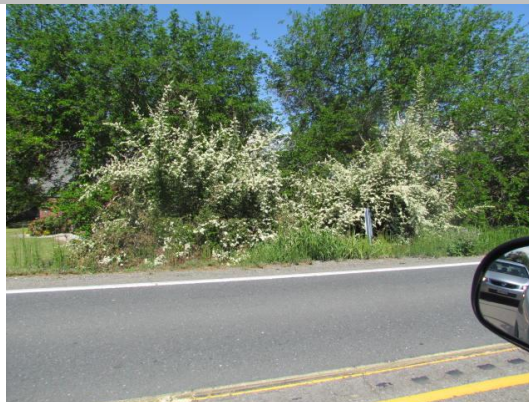
Photo 1 of 2 : SP\_2015\_RD0003\_25\_13\_20150309\_00016.jpg

Action/Comments					
Landscaping

Looking west at vegetation on landward shoulder.

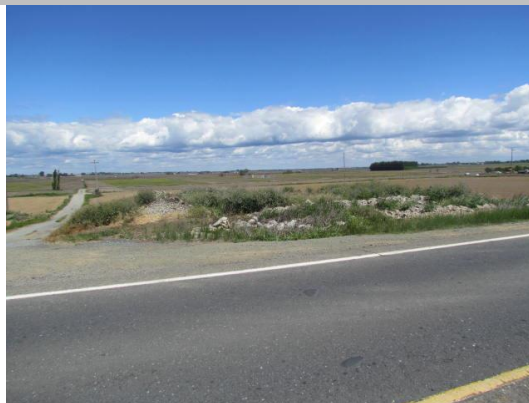
Photo 1 of 1 : SP\_2015\_RD0003\_25\_76\_20150309\_00056.jpg

LM Start	5.35	Rating **	M	Issue No.	76
LM End	5.35	Issue Type +	En	Location *	LS
Category	Earthen Levee			GPS Latitude/Longitude	
				Start	End
Item	Encroachments			38.191392 °	38.191392 °
				-121.574832 °	-121.574832 °
DWR ID	DWR_RD0003_02_s_2013_76				
Action/Comments					
Material					
Inspector Comments: Concrete rubble on landward slope.

Looking west at concrete rubble on landward shoulder and slope.

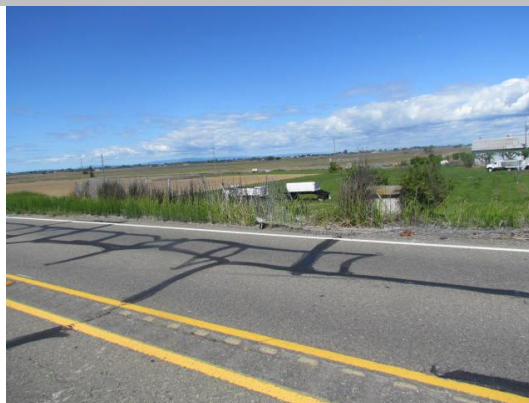
Photo 1 of 1 : SP\_2015\_RD0003\_25\_21\_20150309\_00025.jpg

LM Start	5.53	Rating **	M	Issue No.	21
LM End	5.56	Issue Type +	En	Location *	LS
Category	Earthen Levee			GPS Latitude/Longitude	
				Start	End
Item	Encroachments			38.192358 °	38.192458 °
				-121.571742 °	-121.571320 °
DWR ID	DWR_RD0003_02_s_2012_21				
Action/Comments					
Fence					
Inspector Comments: Fence on landward shoulder.

Looking west at cyclone fence on landward shoulder.

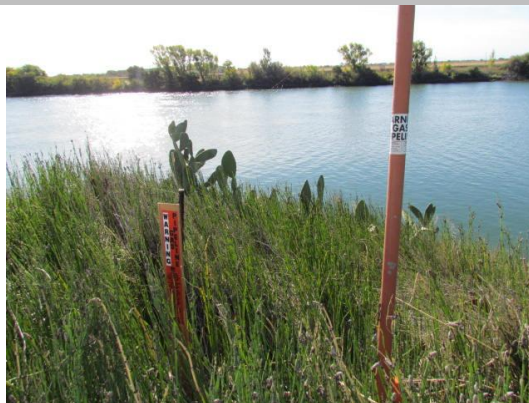
Photo 1 of 1 : SP\_2015\_RD0003\_25\_98\_20150309\_00072.jpg

LM Start	5.72	Rating **	U	Issue No.	98
LM End	5.72	Issue Type +	Ma	Location *	WS
Category	Earthen Levee			GPS Latitude/Longitude	
				Start	End
Item	Vegetation				°
					°
DWR ID	DWR_RD0003_02_f_2013_98				
Action/Comments					
Remove the wild growth other than native grasses from the levee slopes. Inspector Comments: Dense vegetation and cactus on waterward slope.

Looking east at dense vegetation and cactus on waterward slope.

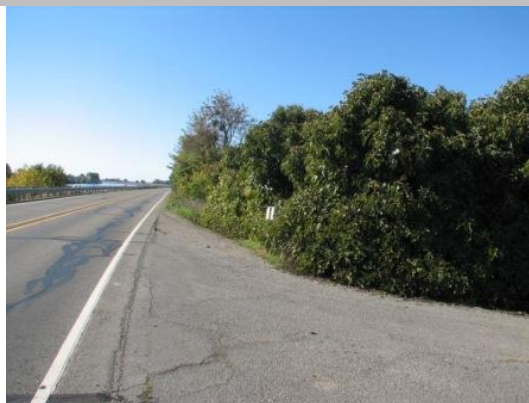
Photo 1 of 2 : SP\_2015\_RD0003\_25\_11\_20150309\_00011.jpg

LM Start	5.81	Rating **	U	Issue No.	11
LM End	5.86	Issue Type +	En	Location *	LS
Category	Earthen Levee			GPS Latitude/Longitude	
				Start	End
Item	Vegetation			38.193552 °	38.193832 °
				-121.566933 °	-121.565995 °
DWR ID	DWR_RD0003_02_s_2012_11				
Action/Comments					
Landscaping

Landscaping on levee slope and toe obstructs access and visibility.

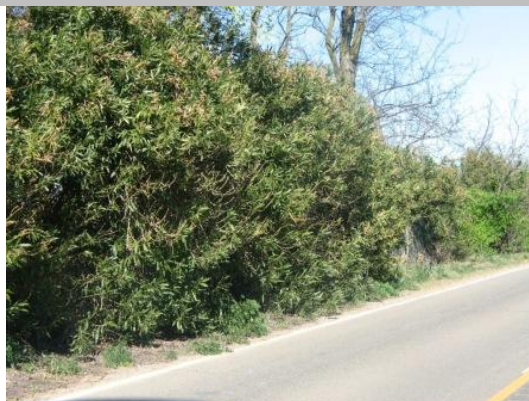
Photo 2 of 2 : SP\_2015\_RD0003\_25\_11\_20150309\_00012.jpg

Oleander on landside shoulder blocking view of levee slope from LM 5.94 to 6.00

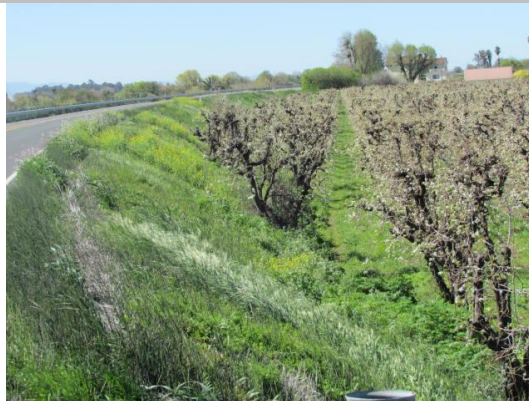
Photo 1 of 1 : SP\_2015\_RD0003\_25\_54\_20150309\_00041.jpg

LM Start	5.98	Rating **	M	Issue No.	54
LM End	6.08	Issue Type +	En	Location *	LS
Category	Earthen Levee			GPS Latitude/Longitude	
				Start	End
Item	Encroachments			38.194705 °	38.195586 °
				-121.564116 °	-121.562669 °
DWR ID	DWR_RD0003_02_s_2012_54				
Action/Comments					
Crops					
Inspector Comments: Orchard on lower levee slope

Looking south at trees on landward toe.

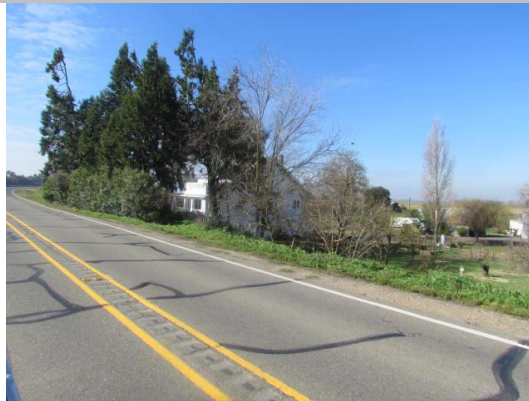
Photo 1 of 1 : SP\_2015\_RD0003\_25\_88\_20150309\_00068.jpg

LM Start	6.53	Rating **	U	Issue No.	88
LM End	6.55	Issue Type +	En	Location *	LS
Category	Earthen Levee			GPS Latitude/Longitude	
				Start	End
Item	Vegetation			38.201255 °	38.201634 °
				-121.558977 °	-121.558886 °
DWR ID	DWR_RD0003_02_s_2012_88				
Action/Comments					
Landscaping

Looking south at landscaping on landside shoulder.

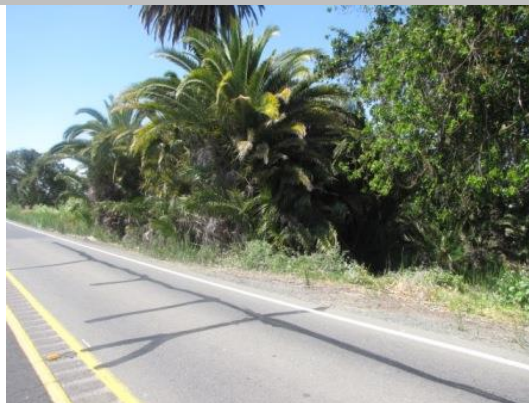
Photo 2 of 3 : SP\_2015\_RD0003\_25\_12\_20150309\_00014.jpg

LM Start	6.88	Rating **	U	Issue No.	12 (cont)
LM End	6.90	Issue Type +	En	Location *	LS
Category	Earthen Levee			GPS Latitude/Longitude	
				Start	End
Item	Vegetation			38.206363 °	38.206598 °
				-121.558520 °	-121.558530 °
DWR ID	DWR_RD0003_02_s_2012_12				
Action/Comments					
Landscaping					
Inspector Comments: Palm trees on landward slope.

Looking southwest at updated dense veg. on landside slope.

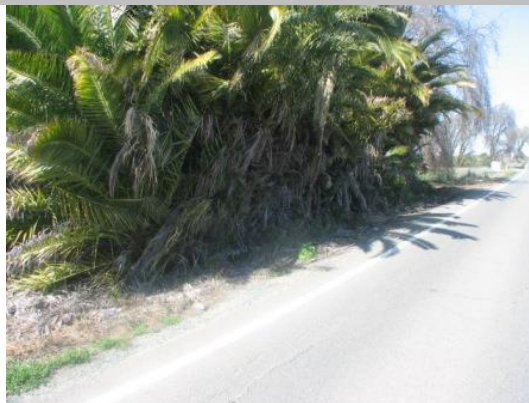
Photo 3 of 3 : SP\_2015\_RD0003\_25\_12\_20150309\_00015.jpg

Front view of palm trees on landside shoulder.

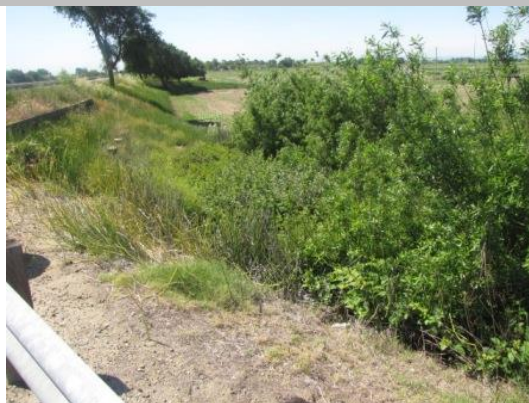
Photo 1 of 1 : SP\_2015\_RD0003\_25\_16\_20150309\_00021.jpg

LM Start	7.01	Rating **	U	Issue No.	16
LM End	7.01	Issue Type +	Ma	Location *	LS
Category	Earthen Levee			GPS Latitude/Longitude	
				Start	End
Item	Vegetation			38.208205 °	38.208205 °
				-121.558565 °	-121.558565 °
DWR ID	DWR_RD0003_02_s_2012_16				
Action/Comments					
Remove the wild growth other than native grasses from the levee slopes.					
Inspector Comments: Dense vegetation at landward toe.

Looking southwest at dense veg. on landside toe.

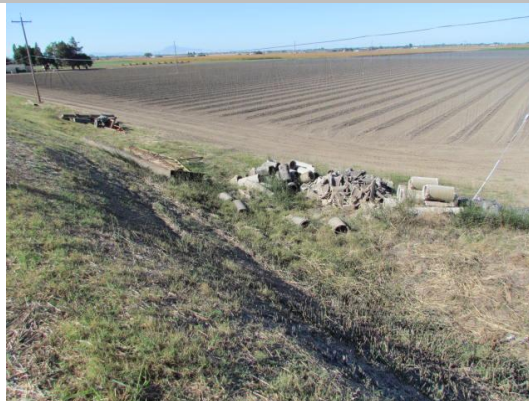
Photo 1 of 1 : SP\_2015\_RD0003\_25\_99\_20150309\_00073.jpg

LM Start	8.03	Rating **	A/W	Issue No.	99
LM End	8.03	Issue Type +	Ma	Location *	LS
Category	Earthen Levee			GPS Latitude/Longitude	
				Start	End
Item	Encroachments				°
					°
DWR ID	DWR_RD0003_02_f_2013_99				
Action/Comments					
Material					
Inspector Comments: Broken concrete pipes and farm equipment at landward toe.

Looking west at broken concrete pipes and farm equipment at landward toe.
